| BOD | 2023MY Niro PHEV, EV (SG2 PHEV, EV) |
| 316 | May 2023 |

TECHNICAL SERVICE BULLETIN

SUBJECT: **SERVICE ACTION: ICU FUSE LABEL REPLACEMENT (SA530)**

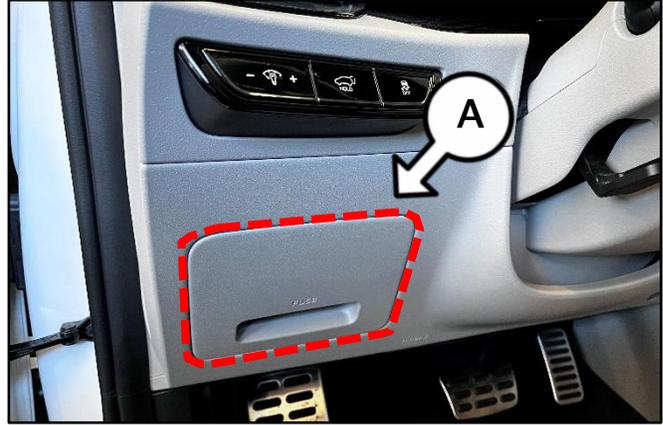
1. Locate the ICU fuse panel cover (A).
